**ASBESTOS SURVEY REPORT
11-12 Amber Court
Colbourne Street
Swindon**

Survey reference:
CT/241531

Surveyed on 30th April 2010

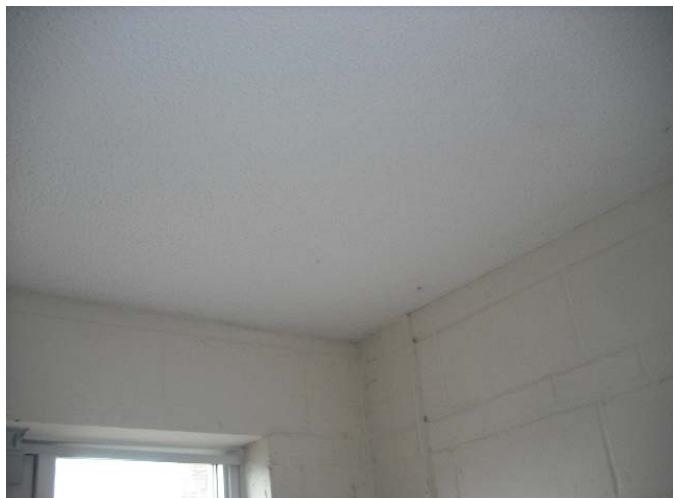
No asbestos identified to Artex located to ceiling stipple effect and in good condition.
 A representative sample was taken from various areas of the artex coating

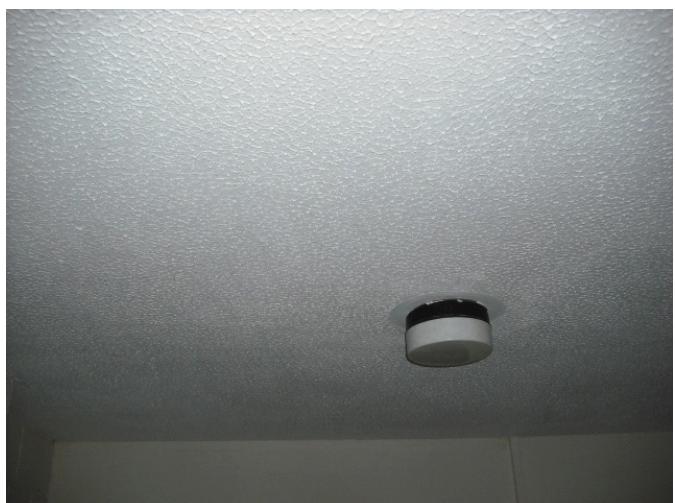
No asbestos identified to Artex located to ceiling stipple effect and in good condition.
 A representative sample was taken from various areas of the artex coating

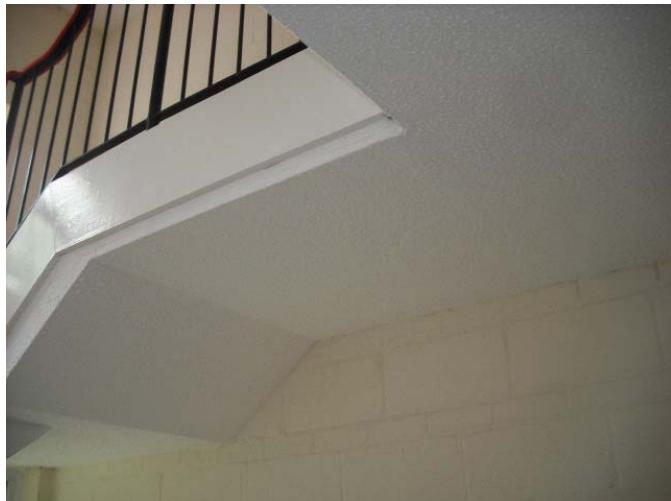
No asbestos identified to Artex coating located to ceilings on all floors of stairwells.

A representative sample was taken of the artex coating from all floor levels throughout stairwell.

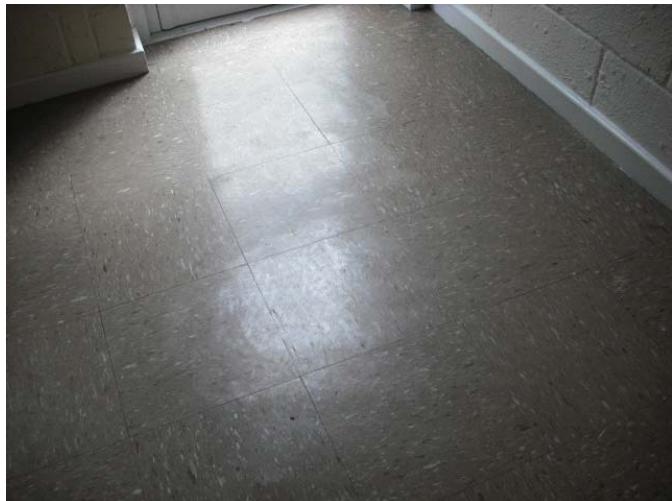
No asbestos identified to floor tiles (brown) located throughout area.

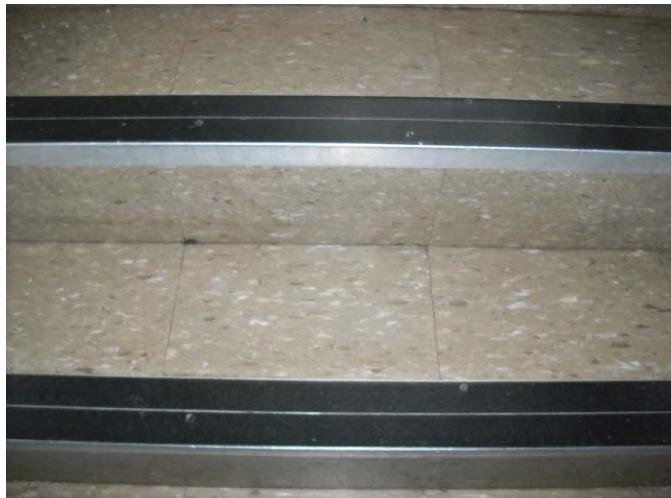
No asbestos identified to stair treads located to front edge of steps.

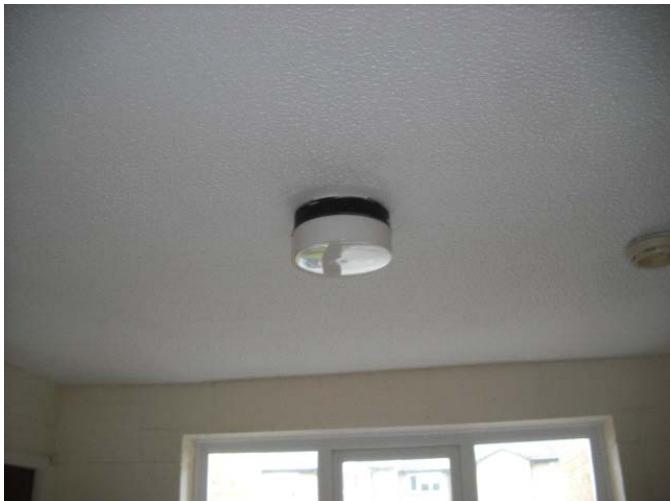
No asbestos identified to Artex coating located to ceiling stipple effect and in good condition.
A representative sample was taken from various areas of the artex coating

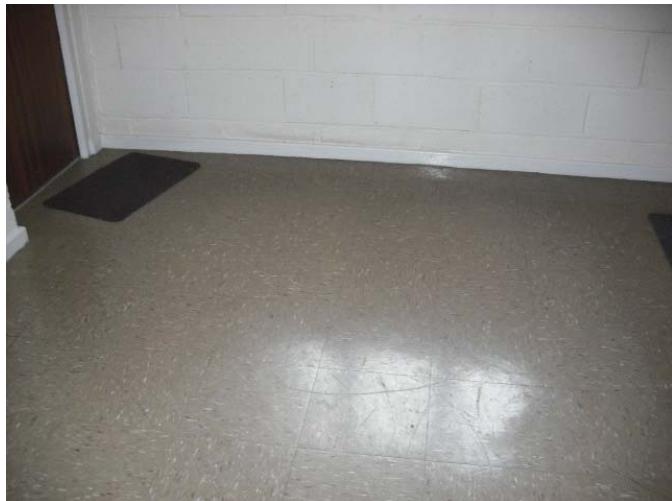
No asbestos identified to floor tiles (brown) located throughout area .

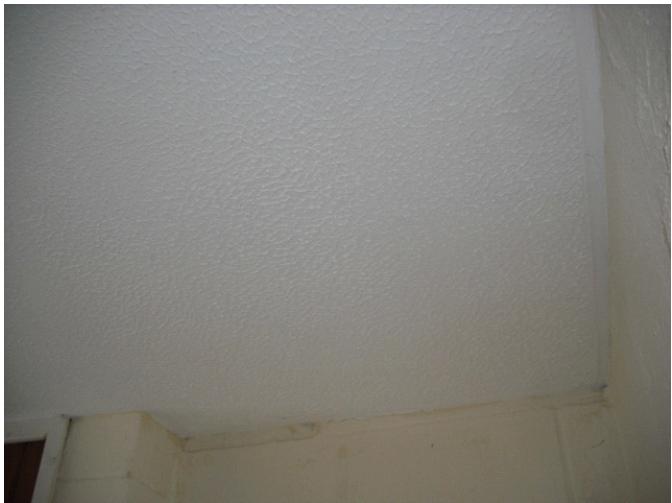
No asbestos identified to Artex coating located to ceiling stipple effect and in good condition.
A representative sample was taken from various areas of the artex coating
