# COMBINED FIRE AND HEALTH & SAFETY RISK ASSESSMENT.

Address of premises:	Amber Court 2 (11-22), Swindon, SN1 2HB
Responsible Person:	Amber Court Management (No 2.) Limited
Duty Holder:	Block Management Limited
Person(s) consulted:	No occupier or other relevant person available to consult.
Assessor:	Rob Cockburn
Report validated by:	John Godfrey, GIfireE.
Date of fire risk assessment:	19 <sup>th</sup> September 2024/ Reviewed September 2025
Date of previous fire risk assessment:	September 2022
Suggested date for review:	September 2026

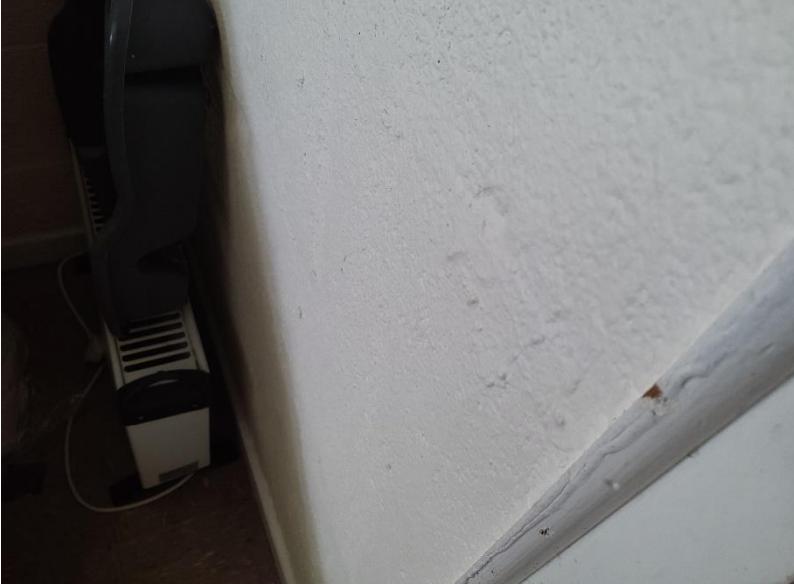
03	<p>There was a portable heater identified during this fire risk assessment. Where portable heaters are used, it is recommended that they are only used when the premises is occupied and are never left unattended. All heaters should be fitted with thermostats, and where possible, timers to ensure that they are never left on overnight.</p> <p>Wherever possible, the fixed heating should be altered or adapted to negate the requirement for portable heaters.</p>

3	B Ongoing Action Required Item belongs to resident. Residents are made aware of sterile area policy via communal notice board. DH conducts regular site inspection and ticket items for removal.

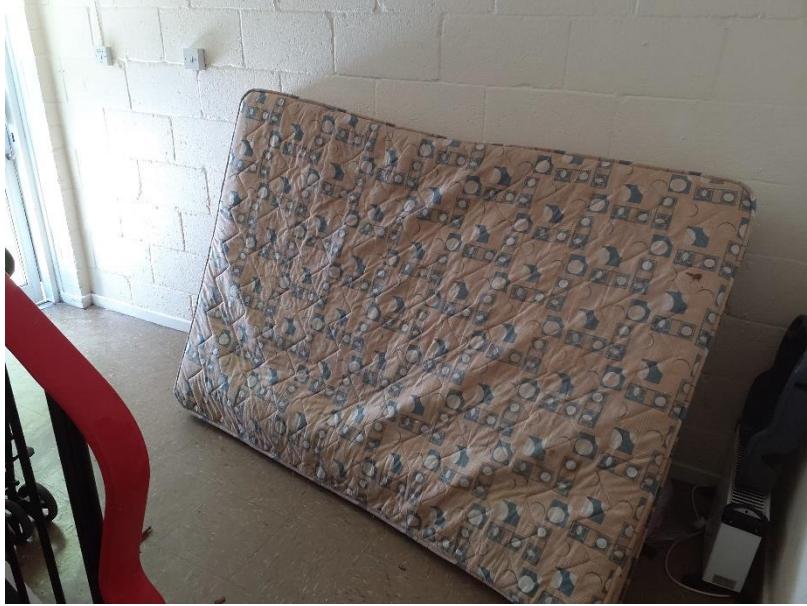
Housekeeping was found to be of a poor standard at the time of this assessment with the communal areas and escape routes congested with residents' possessions and storage. It is recommended that the client arrange for the communal areas to be cleared as a priority and all residents reminded of the importance of maintaining sterile communal areas and escape routes.

04	<p>Housekeeping was found to be of a poor standard at the time of this assessment with the communal areas and escape routes congested with residents' possessions and storage. It is recommended that the client arrange for the communal areas to be cleared as a priority and all residents reminded of the importance of maintaining sterile communal areas and escape routes.</p>

2	B	Ongoing action required As above.
05	<p>All contractors employed by the client must supply risk assessments and method statements prior to working. It is recommended that the client give all contractors induction training prior to commencing work, which should include emergency procedures.</p> <p>Additionally, the client should arrange to conduct a post work inspection of the work area to ensure all works have been completed satisfactorily and safely, with no residual hazards present that could compromise the fire safety of the premises.</p>	3	C	Ongoing action required DH undertake when required.

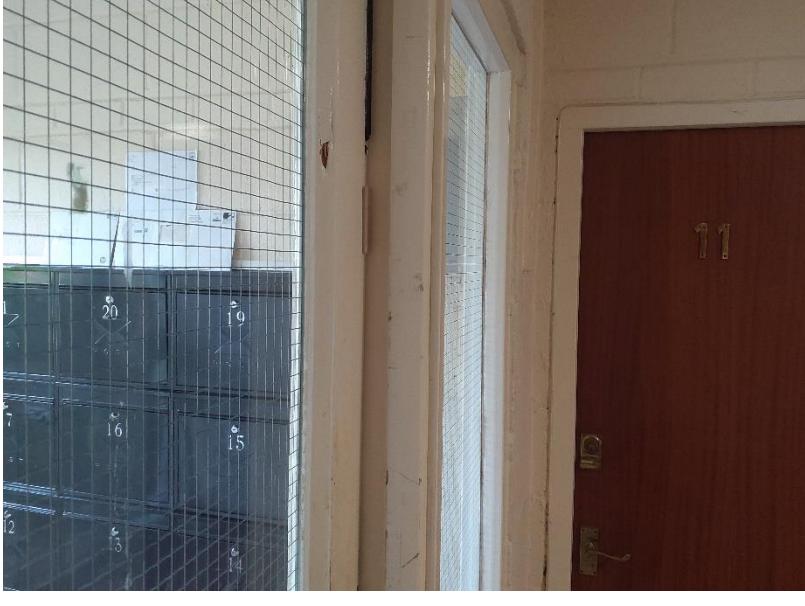
It was noted during this fire risk assessment that the ground floor lobby door to the electrical intake cupboards did not fully self-close. It is recommended that the RP instructs a suitably qualified and competent contractor to ease and adjust the door in order to ensure complete self-closure.

3	B	<p>Ongoing action required Upgrades to be considered by RP.</p>
07	<p>It was noted during this fire risk assessment that the ground floor lobby door to the electrical intake cupboards did not fully self-close. It is recommended that the RP instructs a suitably qualified and competent contractor to ease and adjust the door in order to ensure complete self-closure.</p>

2	B	<p>Ongoing Action required Action complete to lobby door To be monitored</p>

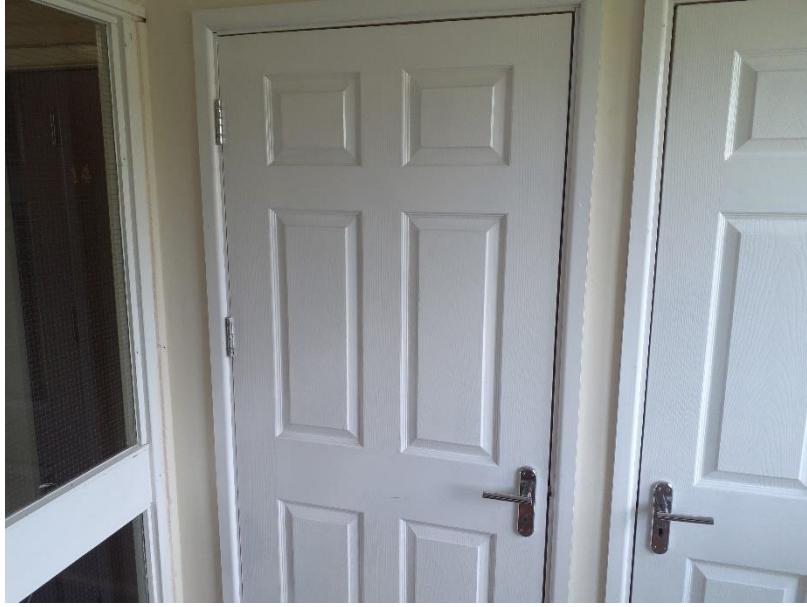
It was noted during this fire risk assessment that the left electrical intake cupboard did not have a lock mechanism installed. It is recommended that the RP instructs a suitably qualified and competent contractor to install an FB lock mechanism in order to protect the means of escape from the spread of smoke and fire.

08	<p>It was noted during this fire risk assessment that the left electrical intake cupboard did not have a lock mechanism installed. It is recommended that the RP instructs a suitably qualified and competent contractor to install an FB lock mechanism in order to protect the means of escape from the spread of smoke and fire.</p>

3	B	Action complete Lock installed to allow access for resident meter reading.
09	<p>It was noted during this fire risk assessment that the intake cupboard doors had intumescent seals only. It is recommended that the RP instructs a suitably qualified and competent contractor to install cold smoke seals to compliment the intumescent seals in order to protect the means of escape from smoke.</p>

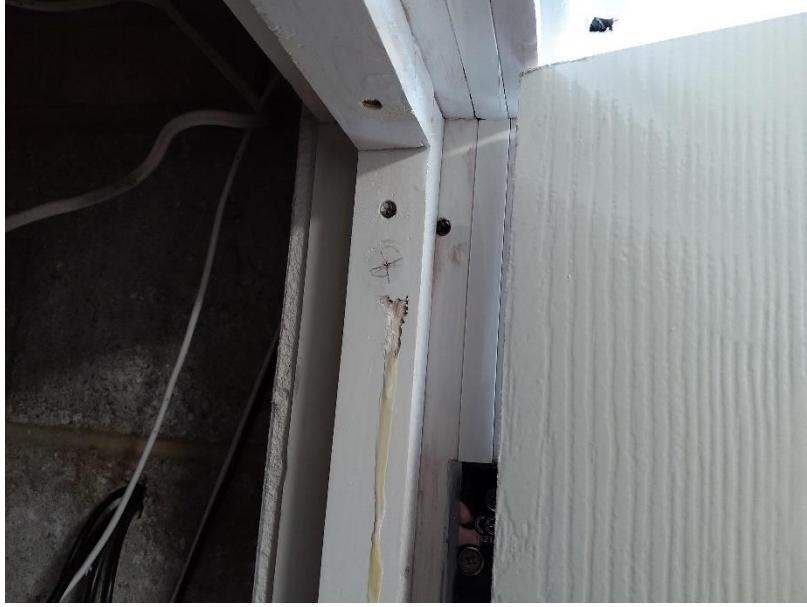
It was noted during this fire risk assessment that the intake cupboard doors had intumescent seals only. It is recommended that the RP instructs a suitably qualified and competent contractor to install cold smoke seals to compliment the intumescent seals in order to protect the means of escape from smoke.

3	B	Action complete

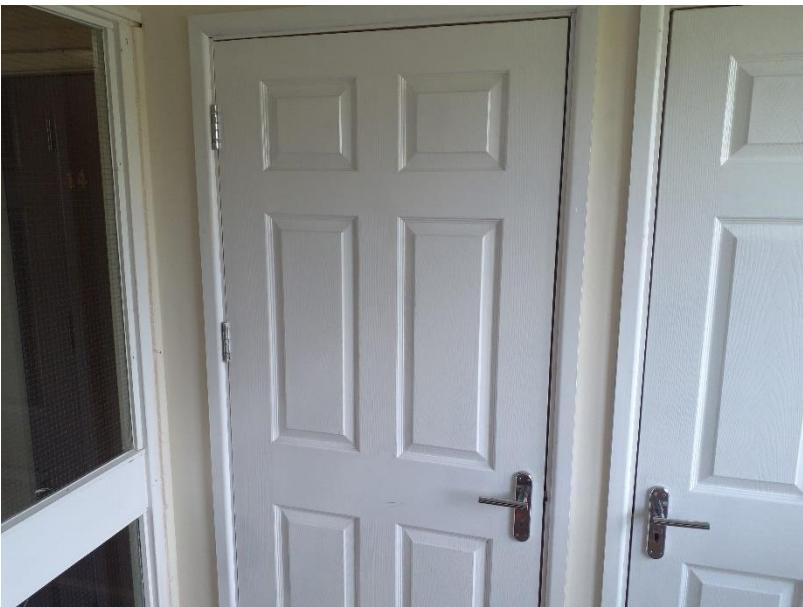
12	<p>It was noted during this fire risk assessment that there was no signage on the left-hand electrical intake cupboard. It is recommended that the RP installs a "Fire Door Keep Locked" sticker to the door.</p>

3	B	Action required Signage to be installed
13	<p>Each flat is responsible for their own fire precautions and it is recommended that the RP advise each resident of the importance of installing smoke detectors within their flat. One battery operated smoke detector in the lobby of each flat would be the minimum provision, however mains powered smoke detectors, each with a battery backup, installed within the escape route of each flat, in all rooms that communicate with the escape route and a heat detector within the kitchen, interlinked to form a BS5839-6: 2019 Grade D detection system with LD2 coverage would be the preferred and safest option for each occupant.</p>	3	C	Ongoing action required DH provide fire safety notice to owners annually

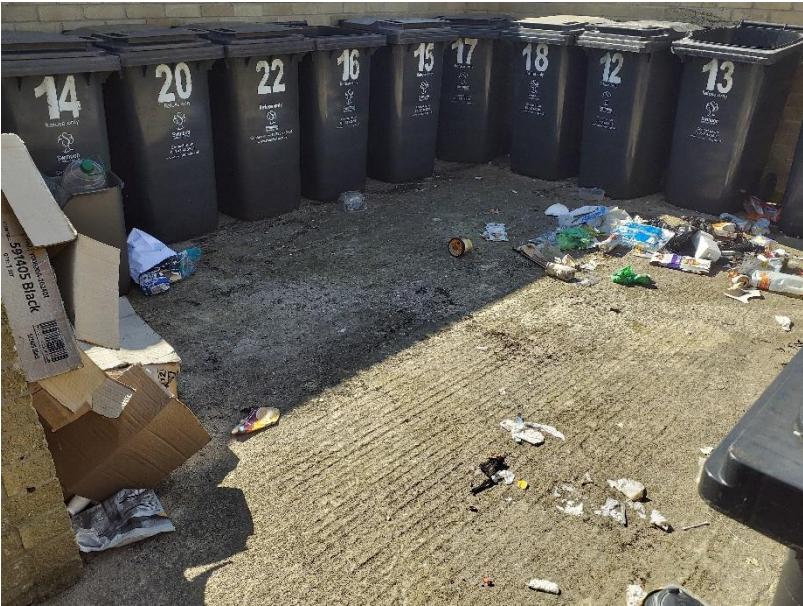
16	<p>It is recommended that a suitable written record of periodic visual inspections of all other external communal areas is implemented by the RP, which should identify any potential hazards including slips or trips from major indentations or imperfections in any surface, including hard and soft landscaping. Any defects identified should be communicated to each resident and repaired by an approved contractor as a priority.</p> <p>Where refuse compounds are identified, an observation regarding waste management should be made as infrequent collections could result in broken glass in the vicinity of the compound leading to possible injury to playing children and a build-up of food waste, which would attract vermin such as foxes, rats or mice.</p>

2	B	<p>Ongoing action required</p> <p>As above. Residents are reminded to dispose of waste correctly. Contractors are engaged to undertake additional work to tidy where required.</p>
