# COMBINED FIRE AND HEALTH & SAFETY RISK ASSESSMENT.

Address of premises:	Amber Court 2 (11-22), Swindon, SN1 2HB
Responsible Person:	Amber Court Management (No 2.) Limited
Duty Holder:	Block Management Limited
Person(s) consulted:	No occupier or other relevant person available to consult.
Assessor:	Rob Cockburn
Report validated by:	John Godfrey, GIfireE.
Date of fire risk assessment:	19 <sup>th</sup> September 2024
Date of previous fire risk assessment:	September 2022
Suggested date for review:	September 2025

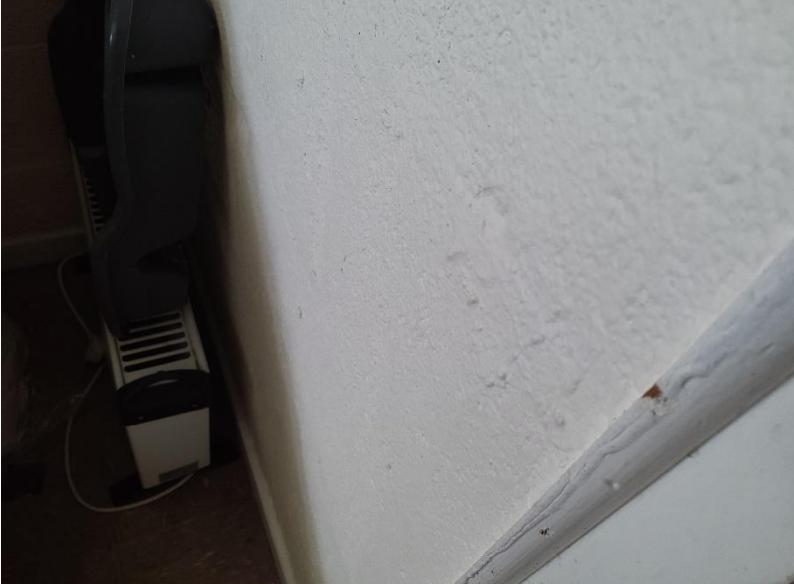
03	<p>There was a portable heater identified during this fire risk assessment. Where portable heaters are used, it is recommended that they are only used when the premises is occupied and are never left unattended. All heaters should be fitted with thermostats, and where possible, timers to ensure that they are never left on overnight.</p> <p>Wherever possible, the fixed heating should be altered or adapted to negate the requirement for portable heaters.</p>

3	B Ongoing Action Required Item belongs to resident. Residents are made aware of sterile area policy via communal notice board. DH conducts regular site inspection and ticket items for removal.

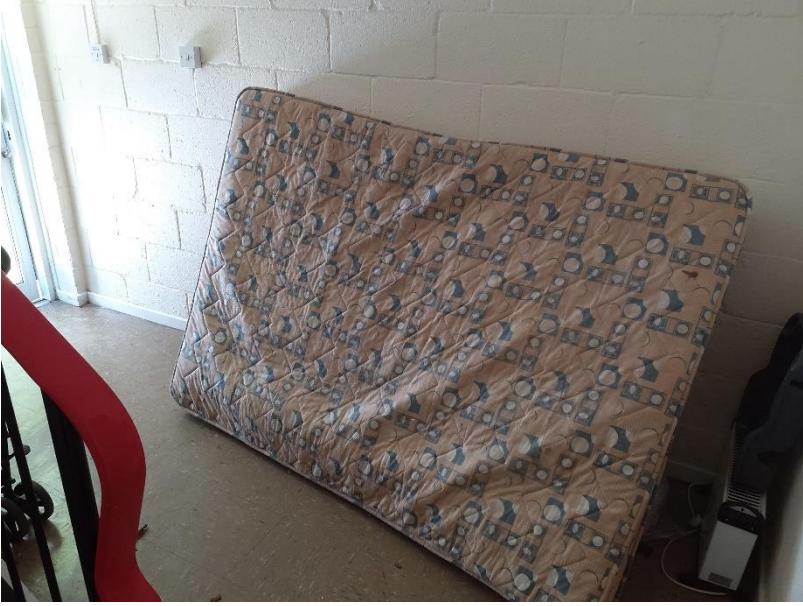
Housekeeping was found to be of a poor standard at the time of this assessment with the communal areas and escape routes congested with residents' possessions and storage. It is recommended that the client arrange for the communal areas to be cleared as a priority and all residents reminded of the importance of maintaining sterile communal areas and escape routes.

04	<p>Housekeeping was found to be of a poor standard at the time of this assessment with the communal areas and escape routes congested with residents' possessions and storage. It is recommended that the client arrange for the communal areas to be cleared as a priority and all residents reminded of the importance of maintaining sterile communal areas and escape routes.</p>

2	B	Ongoing action required As above.
05	<p>All contractors employed by the client must supply risk assessments and method statements prior to working. It is recommended that the client give all contractors induction training prior to commencing work, which should include emergency procedures. Additionally, the client should arrange to conduct a post work inspection of the work area to ensure all works have been completed satisfactorily and safely, with no residual hazards present that could compromise the fire safety of the premises.</p>	3	C	Ongoing action required DH undertake when required.

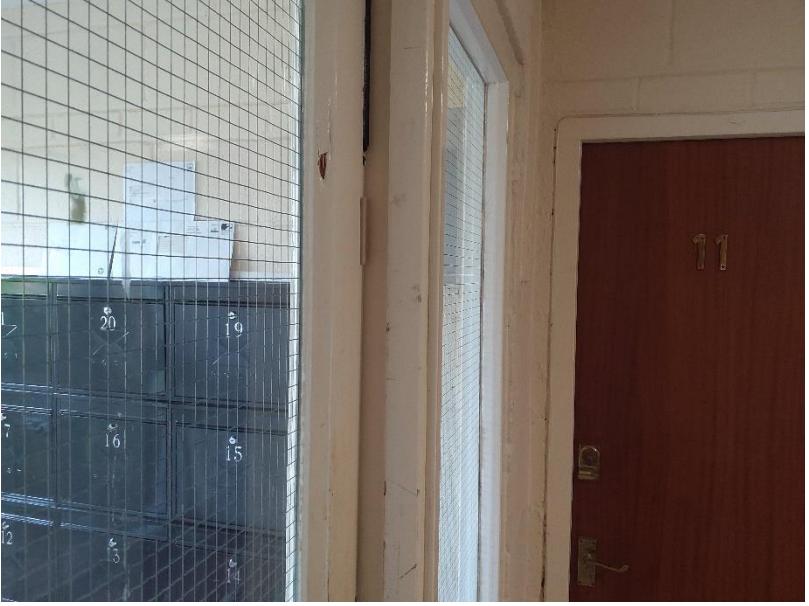
It was noted during this fire risk assessment that the ground floor lobby door to the electrical intake cupboards did not fully self-close. It is recommended that the RP instructs a suitably qualified and competent contractor to ease and adjust the door in order to ensure complete self-closure.

3	B	<p>Ongoing action required Upgrades to be considered by RP.</p>
07	<p>It was noted during this fire risk assessment that the ground floor lobby door to the electrical intake cupboards did not fully self-close. It is recommended that the RP instructs a suitably qualified and competent contractor to ease and adjust the door in order to ensure complete self-closure.</p>

2	B	<p>Action required Contractor to make adjustment</p>

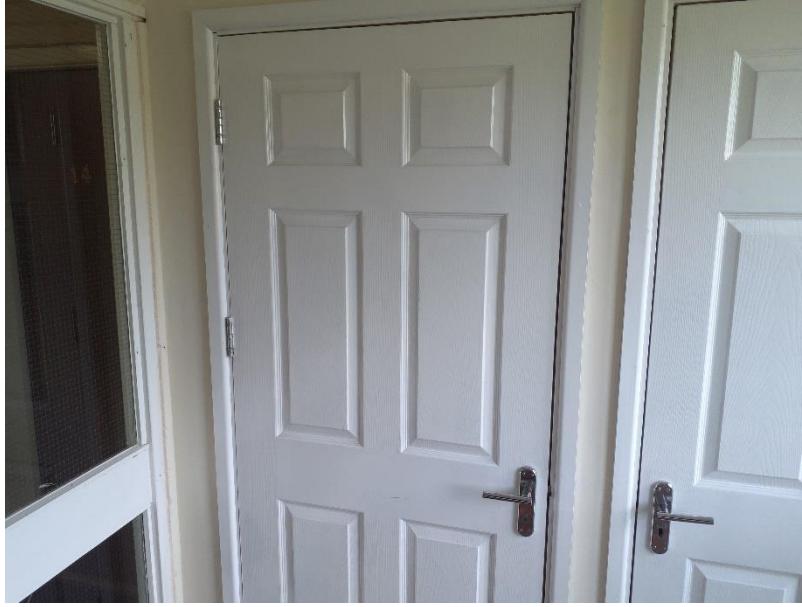
It was noted during this fire risk assessment that the left electrical intake cupboard did not have a lock mechanism installed. It is recommended that the RP instructs a suitably qualified and competent contractor to install an FB lock mechanism in order to protect the means of escape from the spread of smoke and fire.

08	<p>It was noted during this fire risk assessment that the left electrical intake cupboard did not have a lock mechanism installed. It is recommended that the RP instructs a suitably qualified and competent contractor to install an FB lock mechanism in order to protect the means of escape from the spread of smoke and fire.</p>

3	B	<p>Action required Contractor to install code lock to cupboard</p>
09	<p>It was noted during this fire risk assessment that the intake cupboard doors had intumescent seals only. It is recommended that the RP instructs a suitably qualified and competent contractor to install cold smoke seals to compliment the intumescent seals in order to protect the means of escape from smoke.</p>

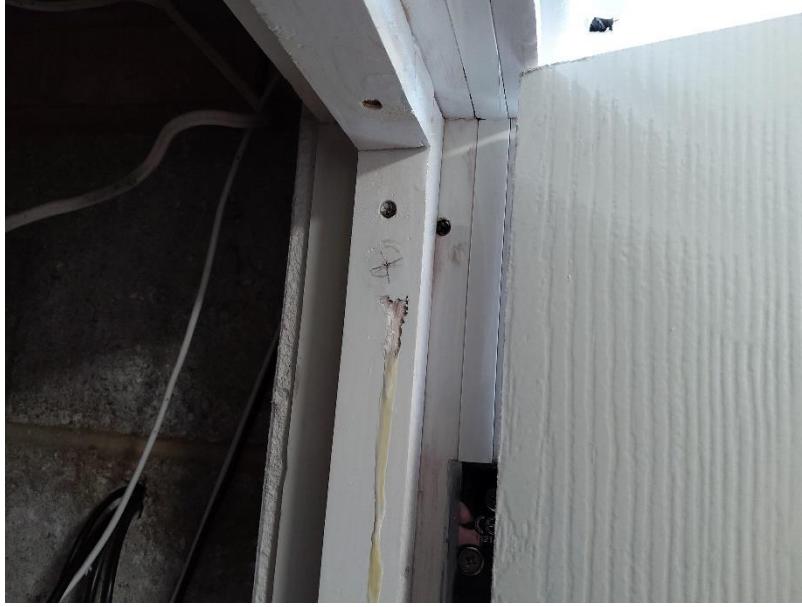
It was noted during this fire risk assessment that the intake cupboard doors had intumescent seals only. It is recommended that the RP instructs a suitably qualified and competent contractor to install cold smoke seals to compliment the intumescent seals in order to protect the means of escape from smoke.

3	B	<p>Action required Upgrades to be considered by RP</p>

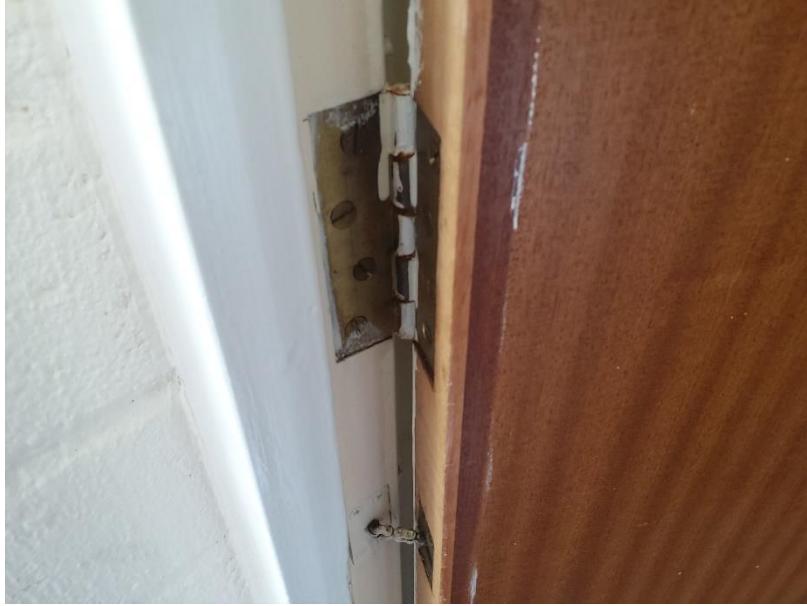
It is essential that each flat entrance door is a suitable fire door, providing a minimum of thirty minutes fire resistance, hung on three grade 13 hinges and having a functioning self-closing device fitted that positively closes the door on the latch, together with smoke and intumescent seals. It is recommended therefore that the RP instruct a suitably qualified and competent contractor to conduct a fire door inspection to all flat entrance doors and communal area doors providing advice on suitability. Any shortcomings identified by this inspection should be addressed as a priority by upgrading or replacing the door.

10	<p>As per section 33.2 of Fire Safety in Purpose-Built Block of Flats a type 1 fire risk assessment requires us to conduct a fire door survey on a sample of flat front doors. The door to flat 18 was surveyed during this sample which appeared to be a notional fire door however it had no fire rate hinges or smoke seals.</p> <p>It is essential that each flat entrance door is a suitable fire door, providing a minimum of thirty minutes fire resistance, hung on three grade 13 hinges and having a functioning self-closing device fitted that positively closes the door on the latch, together with smoke and intumescent seals. It is recommended therefore that the RP instruct a suitably qualified and competent contractor to conduct a fire door inspection to all flat entrance doors and communal area doors providing advice on suitability. Any shortcomings identified by this inspection should be addressed as a priority by upgrading or replacing the door.</p> <p>Flat entrance doors, communal area doors, the seals and the self-closing devices should then be subjected to an annual inspection and maintenance schedule.</p>

1	B	<p>Action required</p> <p>RP to consider upgrades.</p> <p>Inspection carried out November 2023.</p> <p>Re-inspection scheduled for next FRA or before.</p>

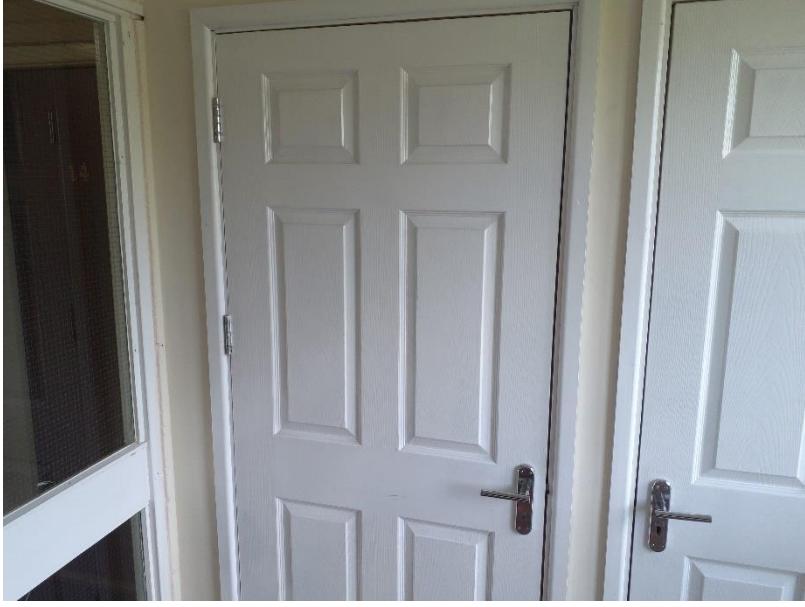
12	<p>It was noted during this fire risk assessment that there was no signage on the left-hand electrical intake cupboard. It is recommended that the RP installs a "Fire Door Keep Locked" sticker to the door.</p>

3	B	Action required Signage to be installed
13	<p>Each flat is responsible for their own fire precautions and it is recommended that the RP advise each resident of the importance of installing smoke detectors within their flat. One battery operated smoke detector in the lobby of each flat would be the minimum provision, however mains powered smoke detectors, each with a battery backup, installed within the escape route of each flat, in all rooms that communicate with the escape route and a heat detector within the kitchen, interlinked to form a BS5839-6: 2019 Grade D detection system with LD2 coverage would be the preferred and safest option for each occupant.</p>	3	C	Ongoing action required DH provide fire safety notice to owners annually

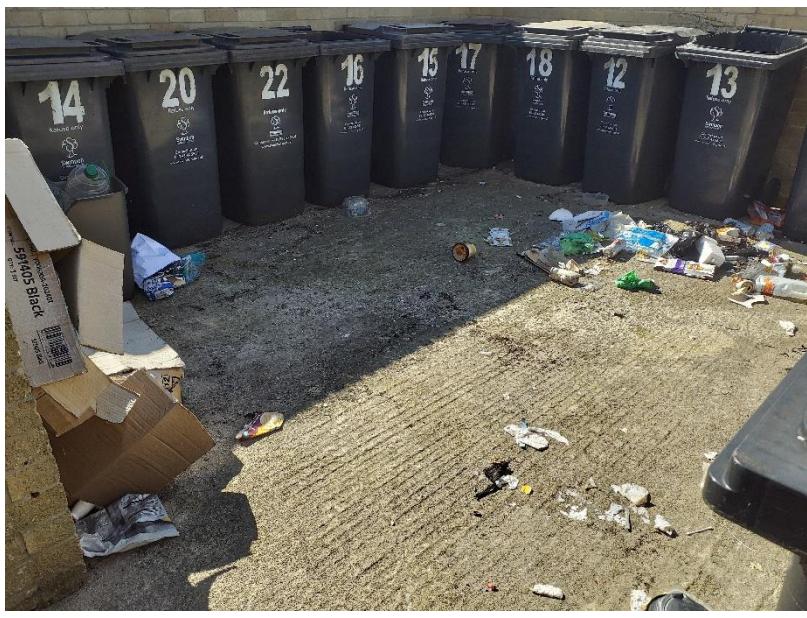
16	<p>It is recommended that a suitable written record of periodic visual inspections of all other external communal areas is implemented by the RP, which should identify any potential hazards including slips or trips from major indentations or imperfections in any surface, including hard and soft landscaping. Any defects identified should be communicated to each resident and repaired by an approved contractor as a priority.</p> <p>Where refuse compounds are identified, an observation regarding waste management should be made as infrequent collections could result in broken glass in the vicinity of the compound leading to possible injury to playing children and a build-up of food waste, which would attract vermin such as foxes, rats or mice.</p>

2	B	<p>Ongoing action required</p> <p>As above. Residents are reminded to dispose of waste correctly. Contractors are engaged to undertake additional work to tidy where required.</p>
